REPORT OF APOLLO 204 REVIEW BOARD

**APPENDIX D
PANEL 18**

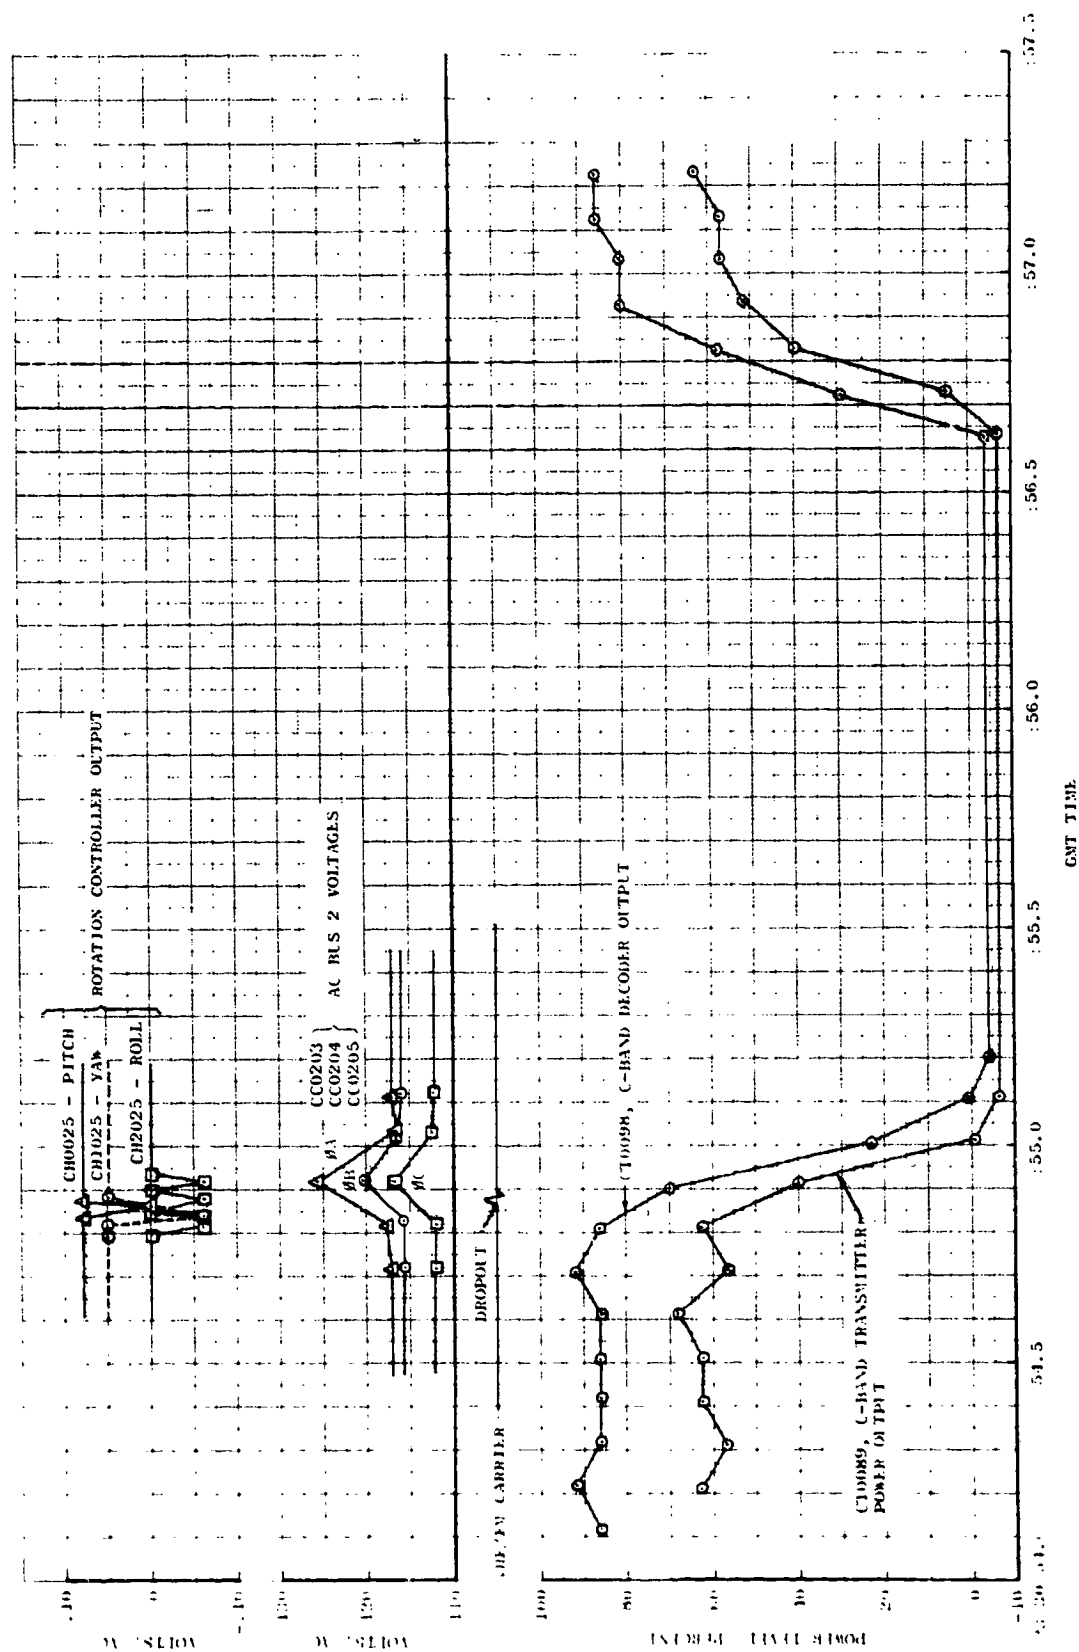
ENCLOSURE 18-8

A momentary increase in AC bus 2 voltage was noted at approximately nine seconds before the crew report of fire, and at the same time the recorded parameters monitoring the equipment powered from AC bus 2 showed abnormal indications. Enclosure 18-3 shows the parameters and changes, with the times of sampling by the telemetry system. These were:

It is concluded that the probable cause of the AC bus 2 transient and associated indications was a momentary short (2 to 25 milliseconds) of DC bus B affecting the input voltage to inverter 2.

AC BUS 2 DATA AND ASSOCIATED CHANGES

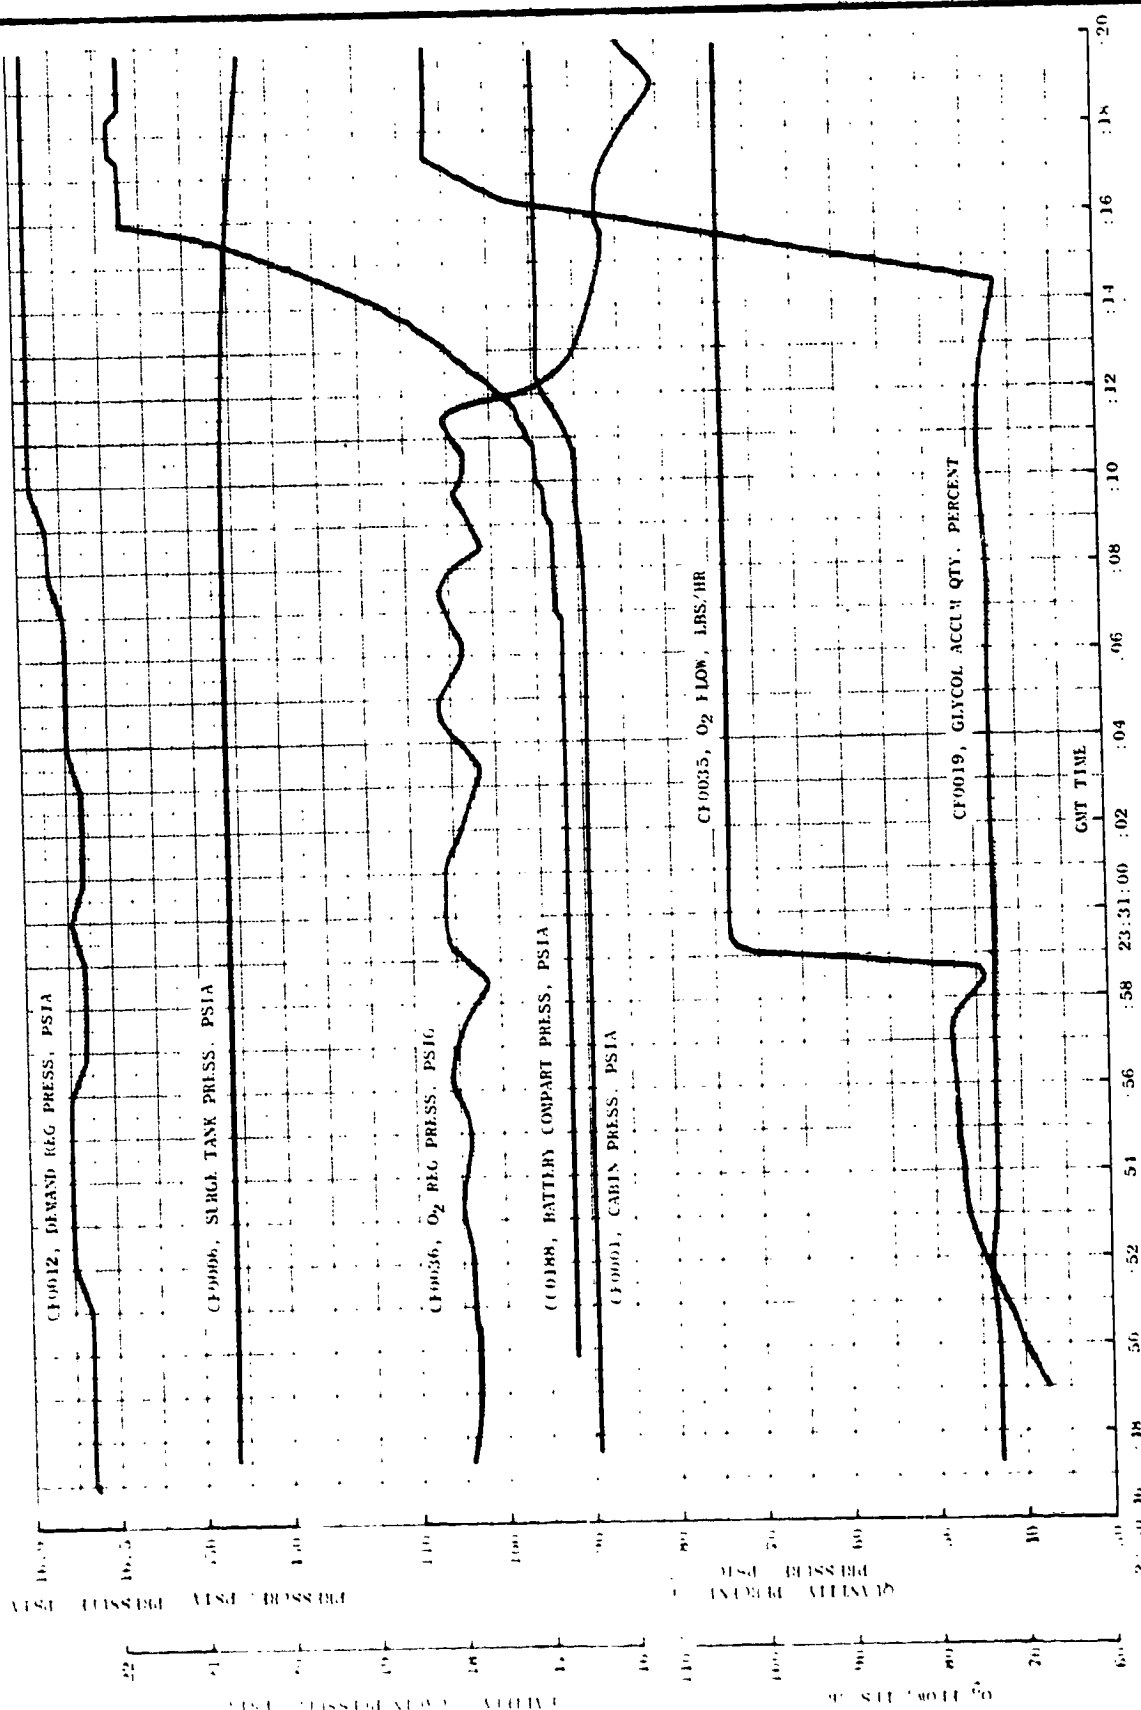
ENCLOSURE 18-9

At 23:30:59 GMT the oxygen flow rate measurement went to a saturated condition of 1.03 pounds per hour. Fifteen seconds later the caution and warning system master alarm was triggered. The oxygen (O_2) flow stayed in a saturated condition until loss of signal (LOS). Oxygen flow rate and associated data are shown in Enclosure 18-9.

OXYGEN FLOW RATE AND ASSOCIATED DATA

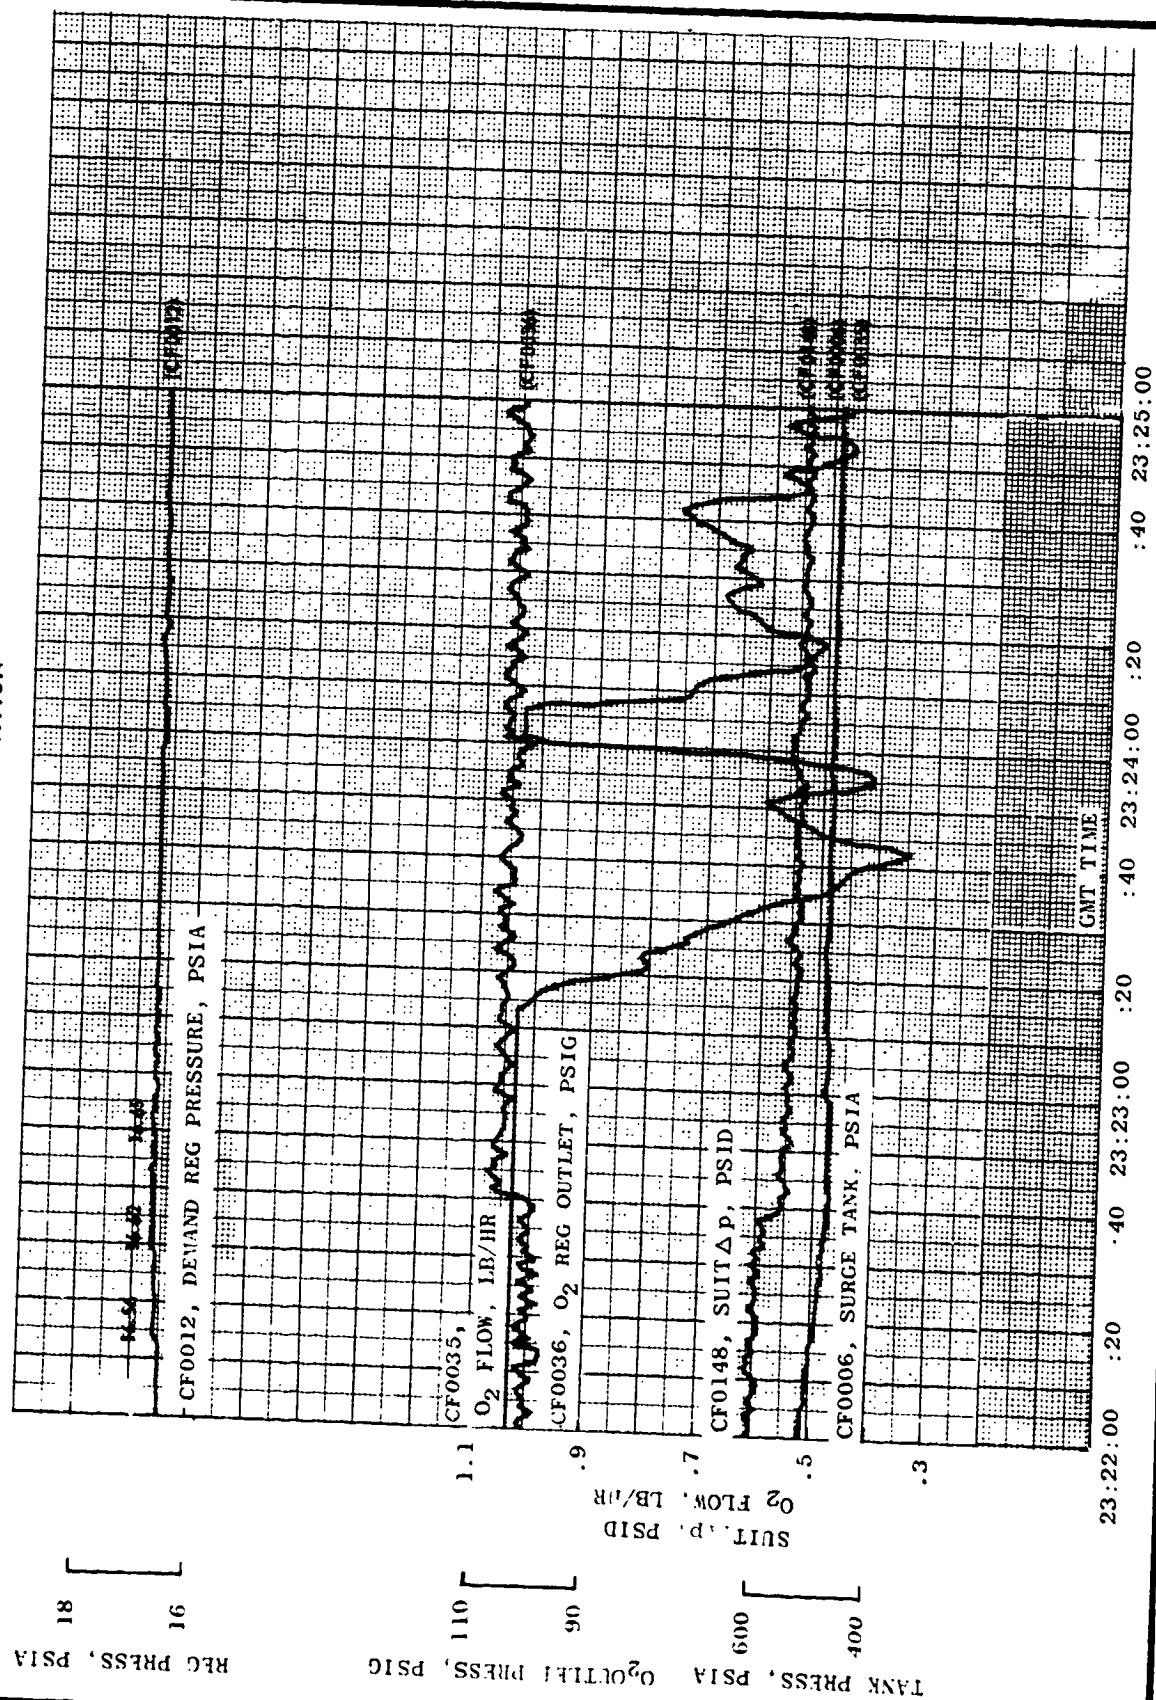
ENCLOSURE 18-12

(3) Open Helmet Visor - Enclosure 18-12 shows that with an open helmet visor (23:19:13 GMT), Surge Tank Pressure responds within about 5 seconds. For this condition the surge tank pressure decayed from 739 to 480.6 psig (see Enclosure 13-13 which shows the history of surge tank pressure for the entire test). During the last high-O₂ flow condition the surge tank does not start decreasing for 12 seconds.

NOTE: Average flows computed from surge tank pressure data. •Voice tape indicates crew activity. ••Command Pilot face plate open.

ECS DATA CORRELATION

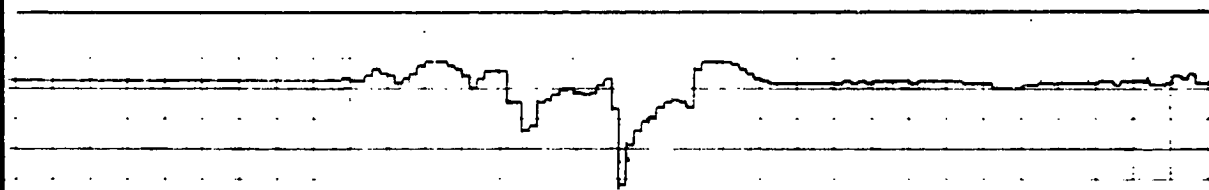
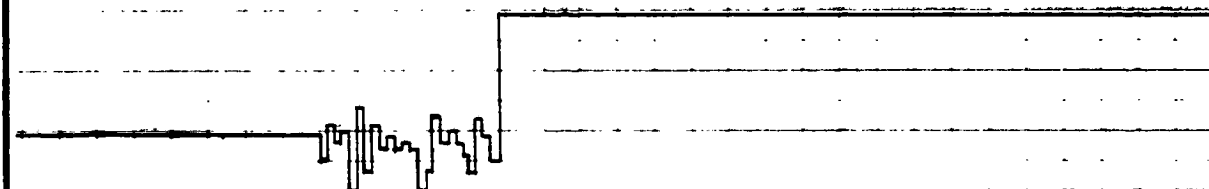
ENCLOSURE 18-21

Tests were conducted at MSC and at the Contractor's facility to determine what physical phenomena can cause an output to be produced from a powered and open gas chromatograph electrical connector. Enclosure 18-21 shows the variations from two of these tests compared with the output from S/C 012. Trace A shows the output from a S/C 008 test at MSC, during the period of time when a plastic bag was being removed from the connector, where the wiring and connector were touched with bare hands. Trace C shows the output from a North American Aviation, Downey, California, test during the period of time when the wiring and the connector were subjected to an external flame. The composite data from all special test indicate that an output from the connector can be produced by the following:

GAS CHROMATOGRAPH TRACE COMPARISON

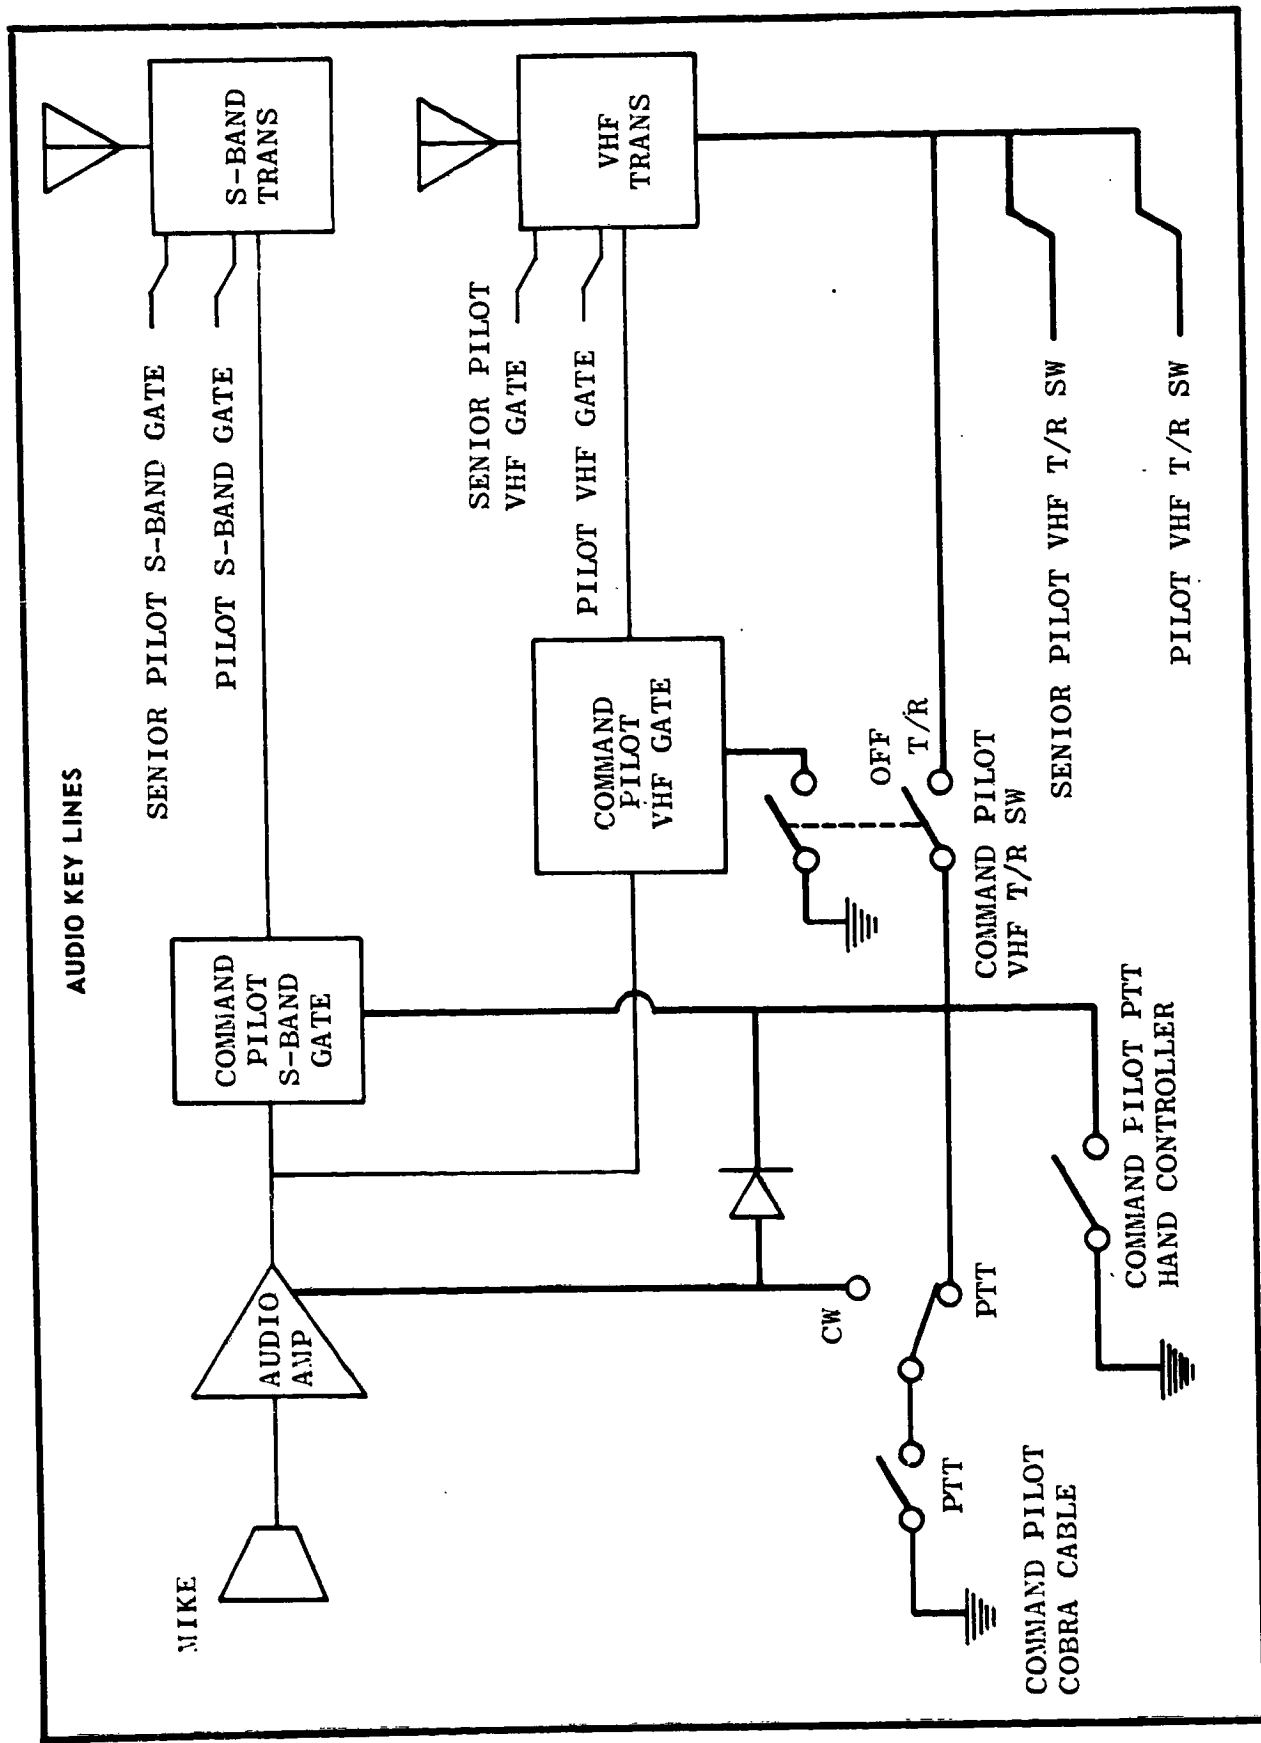
ENCLOSURE 18-24

The live microphone connotation means that the microphone amplifier in the audio center has received a ground, allowing 28 volts DC to energize the amplifier electronics, and the diode gates in the audio center on the S-band audio output have been grounded, allowing audio signals to modulate the S-band transmitter. These two conditions are normally effected by a crewman pressing his Push-to-Talk (PTT) button on the cobra cable, or in the Command Pilot's case, by pressing his translation controller PTT or his cobra cable PTT button. The PTT button, in addition to the above function, provides a ground for the VHF/AM Transmitter keying relay through the audio control panel VHF/AM T/R select switch. These VHF/AM T/R switches are connected together for all three astronaut positions which would cause a ground to be transferred among all positions in VHF/AM T/R mode. See Enclosure 18-24 for logic detail.

An analysis of this problem has isolated the cause to the PTT or keying line that runs between the cobra cable, translation controller, Command Pilot audio control panel, and the audio center (circuitry shown in Enclosure 18-24). The following has been determined:
